"Full" Reserve Study

Wavecrest Resort Inc. Kaunakakai, HI

Report #: 37708-0
For Period Beginning: January 1, 2021
Expires: December 31, 2021

Date Prepared: March 4, 2020

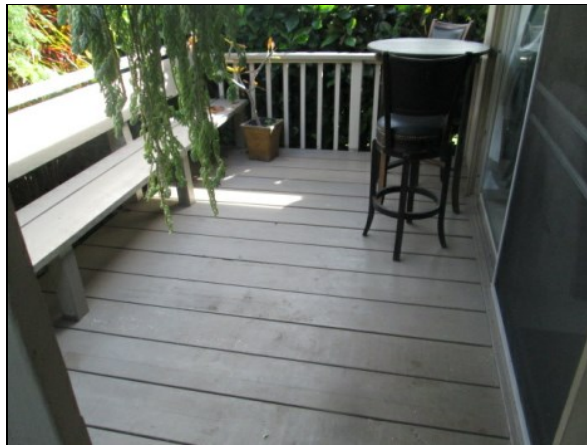
Comp #: 109 Wood Deck - Replace

Useful Life:
20 years

Remaining Life:
0 years
