"Full" Reserve Study

Wavecrest Resort Inc. Kaunakakai, HI

Report #: 37708-0
For Period Beginning: January 1, 2021
Expires: December 31, 2021

Date Prepared: March 4, 2020

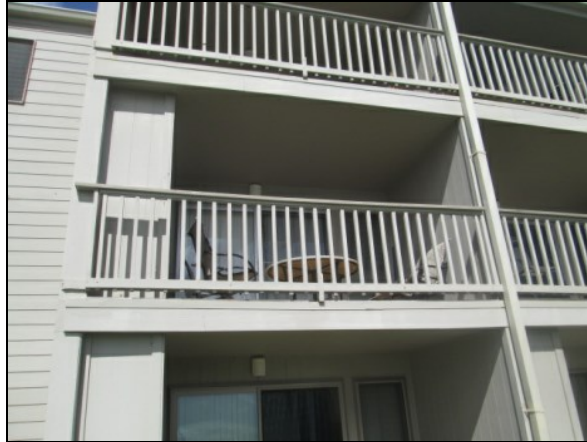
Comp #: 109 Wood Deck - Replace

Comments: The wood deck is old, worn and deteriorated at this time. Many loose boards witnessed during inspection. In poor overall condition.

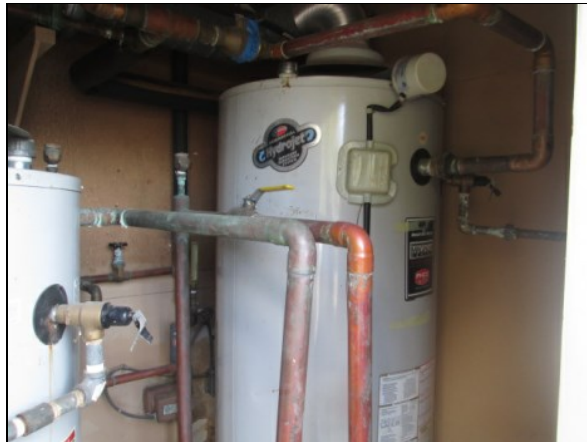
Comp #: 801 Bldg B Boiler - Replace (2016)

History: Replaced in 2016.

Comments: Tank exhibits minor wear/tear and usage. No rust or leaks detected during inspection. In fair condition.

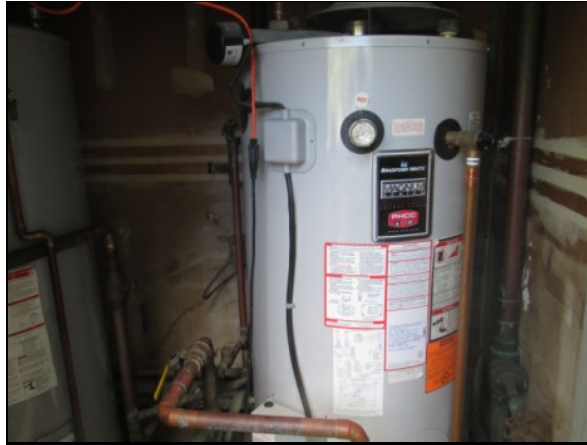
Comp #: 801 Bldg C Boiler - Replace (2004)

History: Replaced in 2004.

Comments: This tank is reported to be functional, but is older and worn. In declining condition. Plan to replace in the near future due to age.

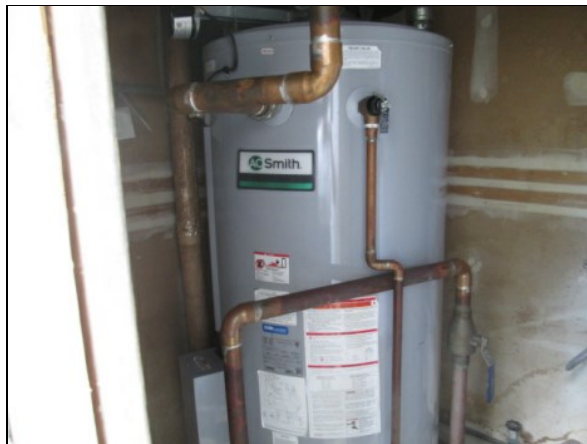
Comp #: 801 Bldg C Boiler - Replace (2017)

History: Replaced in 2017.

Comments: Tank exhibits minor wear/tear and usage. No rust or leaks detected during inspection. In good condition.

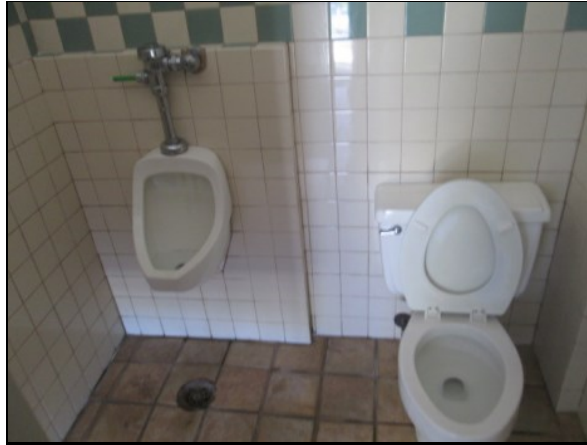
Comments: The bathrooms are older and worn at this time. In declining condition. Plan to refurbish in the near future to restore appearance.

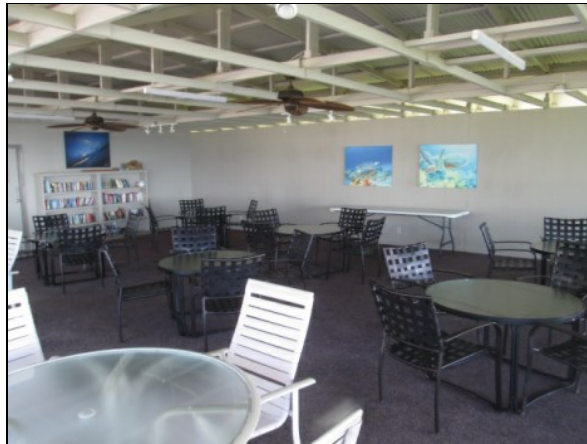
Comments: The room shows general wear/tear and usage. In fair condition. Includes: 1,392 GSF carpet, (8) tables, (34) chairs, (2) drink tables, (2) fold-up tables, (1) bookcase, (3) ceiling fans, (12) ceiling lights.

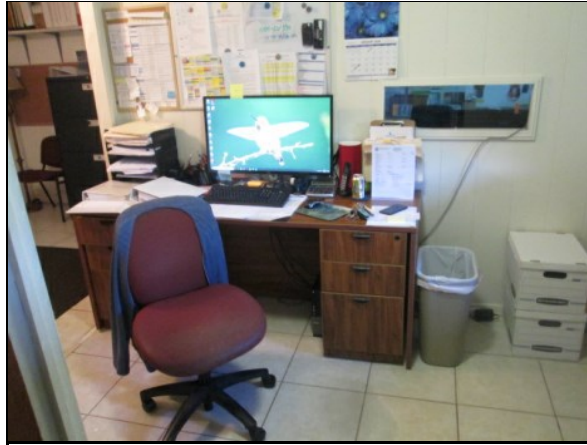
Comments: The office interiors are older and worn at this time. In declining condition. Plan to refurbish in the near future.

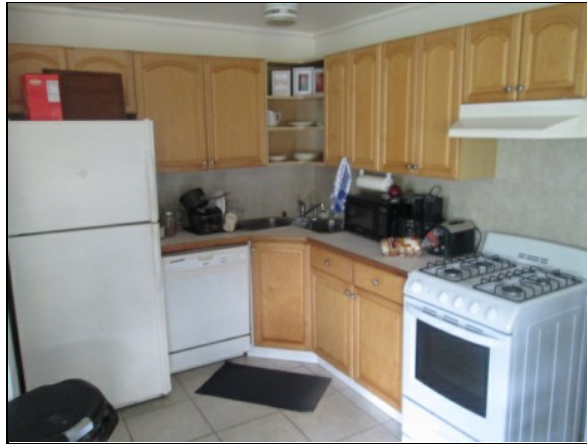
Comments: The unit interiors are older and worn at this time. In declining condition. Plan to refurbish in the near future.

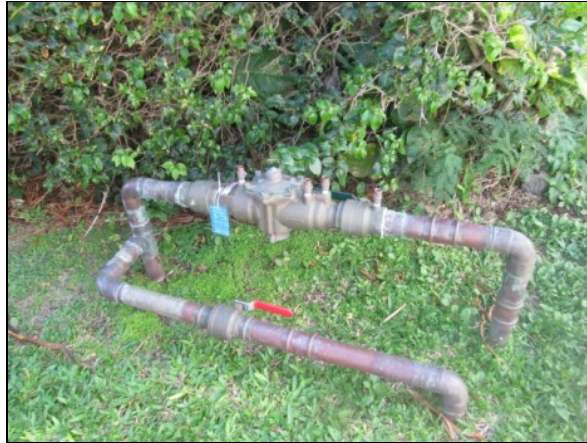
Comp #: 1001 Backflow Devices - Replace

Comments: Not tested during inspection. These devices help to prevent harmful contaminants from getting into your drinking water. Funding has been provided for eventual replacement.

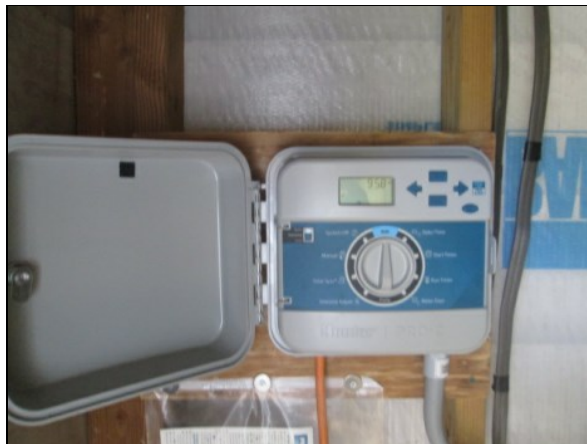
Comp #: 1003 Irrigation Controllers - Replace

Comments: The controllers were not tested during inspection. All are reported to be functional, with no issues at this time. In fair overall condition.

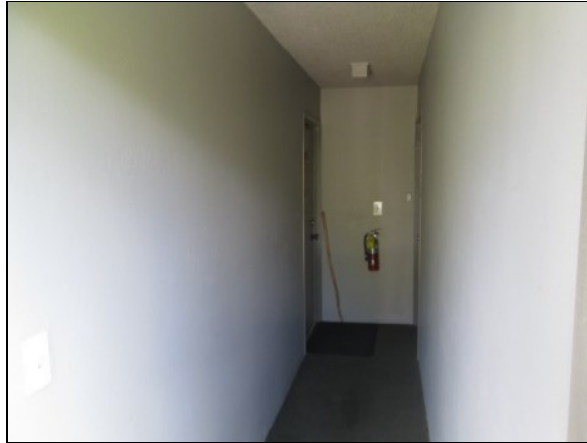
Comments: Chipping, abrasions and grime build-up detected throughout. Paint coverage is in declining condition. Stick to repaint cycles to maintain appearance.

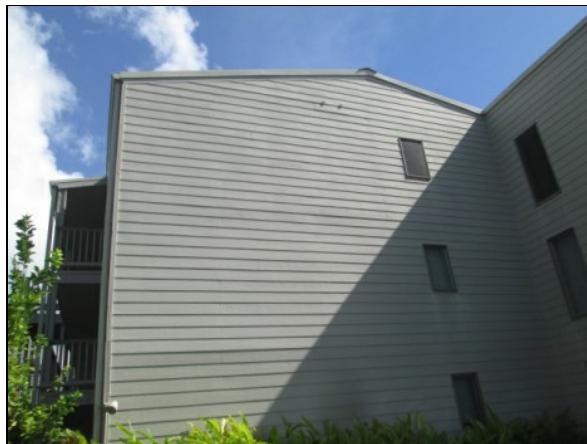
Comments: Surfaces show general wear/tear and are starting to show signs of dryness. Paint coverage is in declining condition. Stick to repaint cycles to maintain this asset.

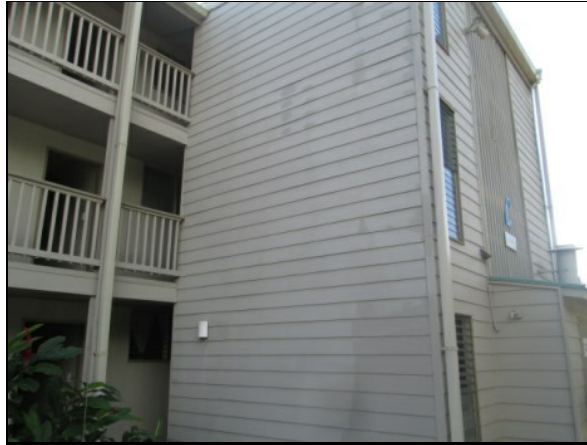
Comp #: 1120 Siding - Replace

Comments: Siding is intact and appears to be aging normally. No significant deterioration or abuse witnessed during inspection. In fair condition. Anticipate the need for eventual replacement.

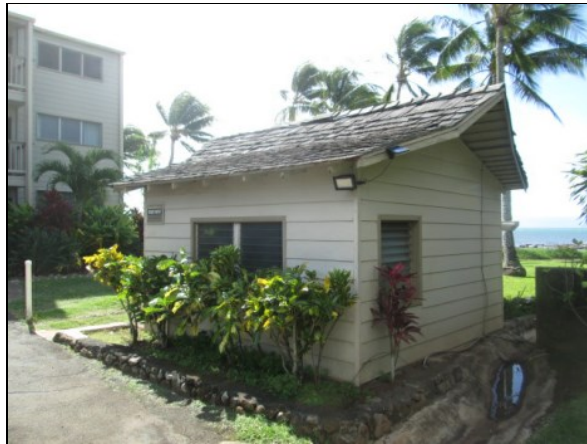
Comments: This building is reported to be old, worn and having issues at this time. In declining condition. Includes: 315 GSF of wood shingle roof and storage inside. Painting/replacement is included with exterior siding (refer to #1116 / #1120).

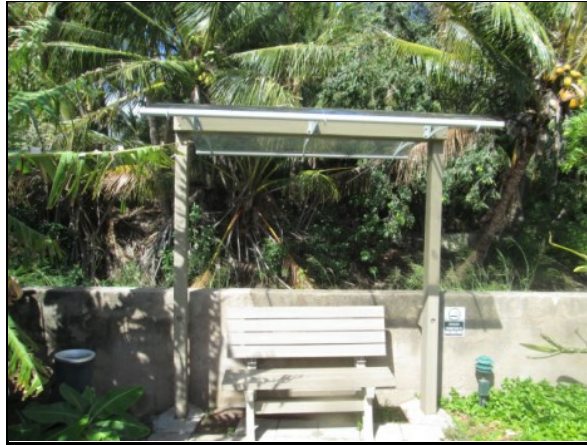
Comp #: 1140 Smoking Stations - Replace

Comments: The structures exhibit general signs of wear/tear and light usage. No major damage or abuse noted. In fair condition.

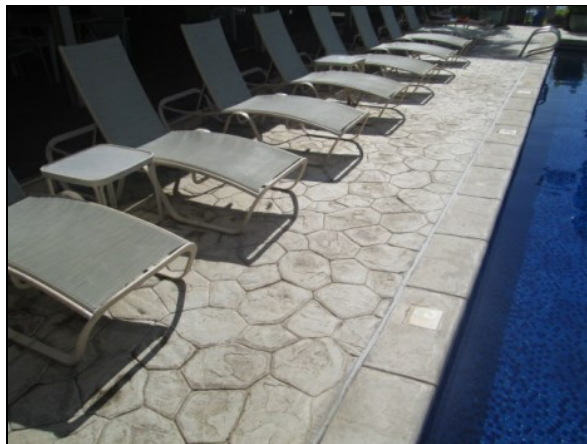
Comp #: 1201 Pool Deck - Replace

Comments: Decking is intact and shows general staining, abrasions and wear. No severe damage or abuse noted. In fair overall condition.

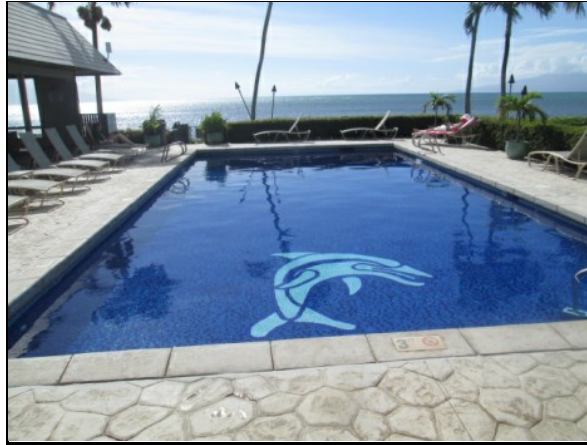
Comments: Moderate grime build-up witnessed during inspection. No cracks or heavy staining noted. In fair overall condition.

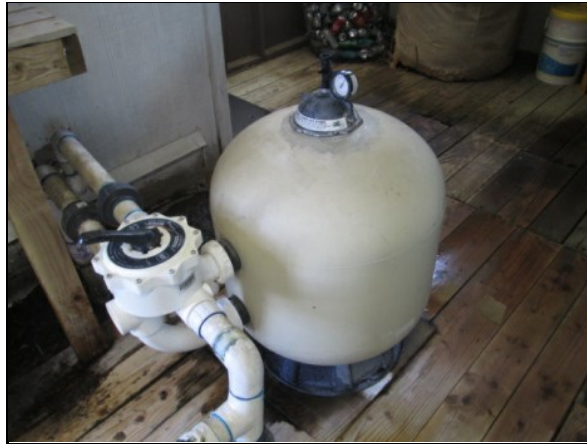
Comp #: 1207 Pool Filter - Replace

Comments: Filter shows general wear/tear and usage. No rust or active leakage detected at this time. In fair condition.

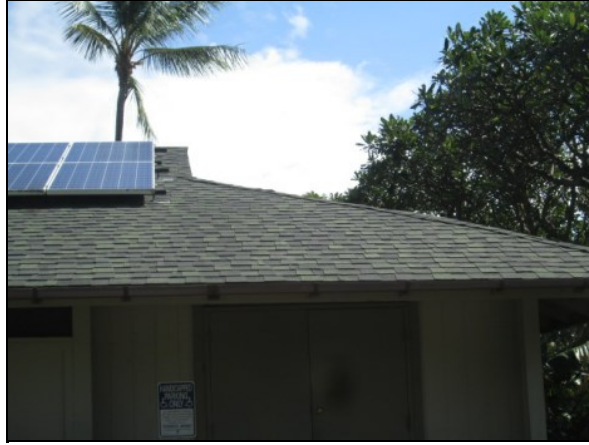
Comp #: 1303 Comp Shingle Roof - Replace

Comments: The shingles are intact and properly aligned. No reports of leaks or other issues at this time. In fair overall condition.

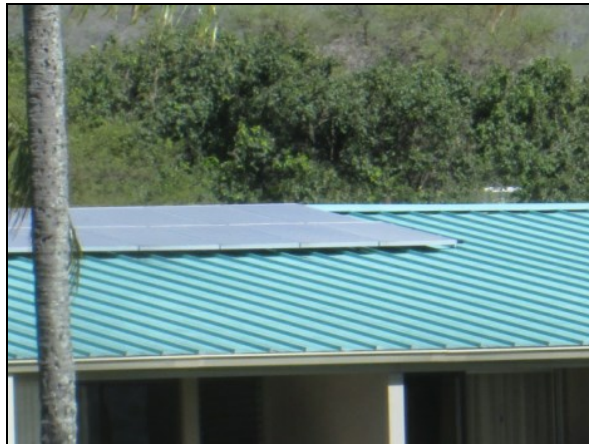
Comp #: 1308 Metal Roofs - Replace

Comments: The metal roofs are intact and appear to be aging normally. No reports of leaks or other issues at this time. In fair overall condition.

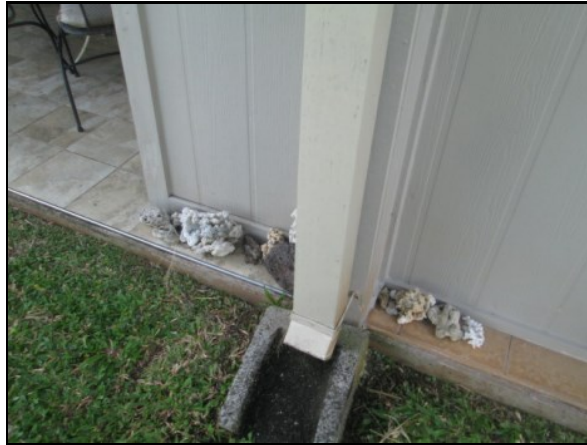
Comp #: 1310 Gutters/Downspouts - Replace

Comments: The gutters are intact and exhibit moderate signs of wear and aging. No severe damage or abuse witnessed. In fair condition. Plan on eventual replacement.

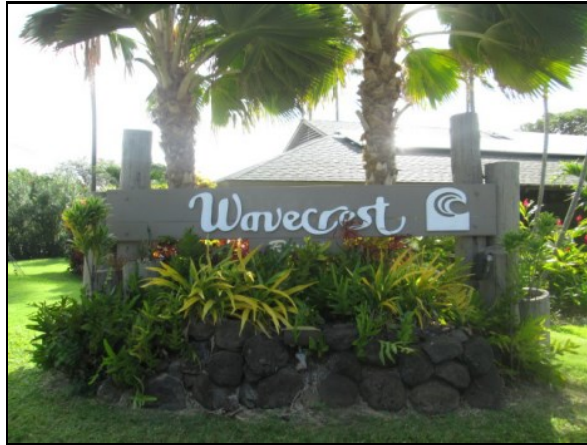
Comp #: 1402 Entry Signage - Replace

Comments: Sign is intact, sturdy and aging normally at this time. No severe damage or abuse witnessed during inspection. In fair overall condition.

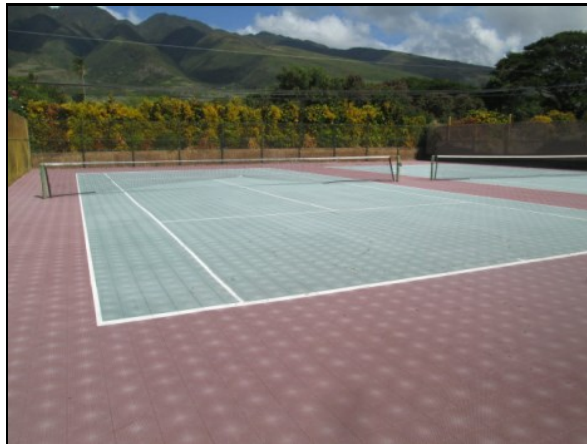
History: Replaced in 2006.

Comments: Courts exhibit general forms of wear/tear and aging at this time. No major damage or abuse detected. In fair and serviceable condition.

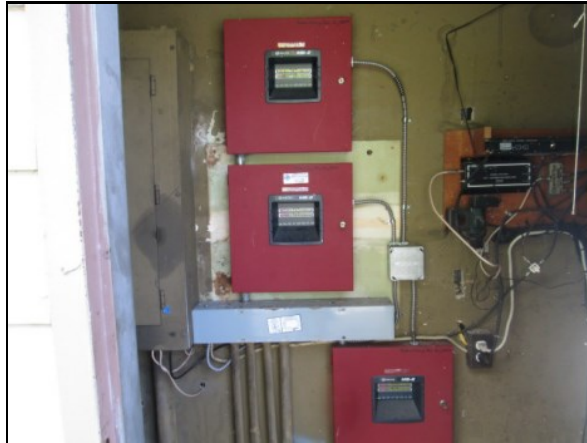
Comp #: 1803 Fire Alarm Panels - Replace

Comments: Not tested, but reported to be functional. There were no reports of service related issues at this time. In fair condition. Funding has been provided for periodic replacement of the panels to ensure proper function.
